**Mini Review***Copyright © All rights are reserved by Glencross Grant R*

Recent Bushfire Impact on Timber Bridges in Northern New South Wales

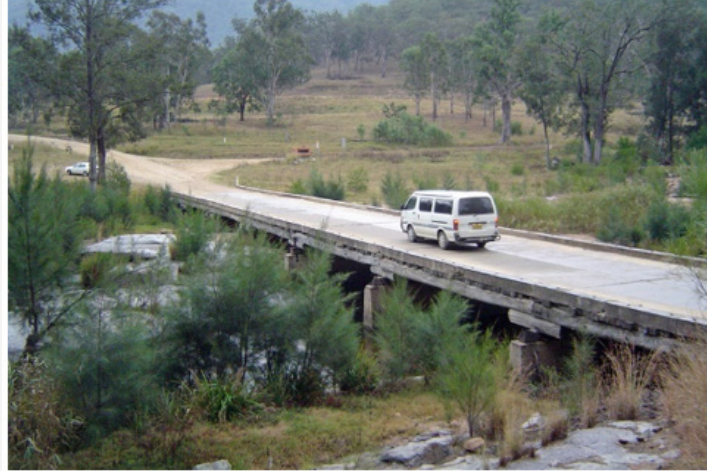
Figure 1: Mann River Bridge, Wyaliba Bridge before fire (Glencross-Gant, 30 April 2007).

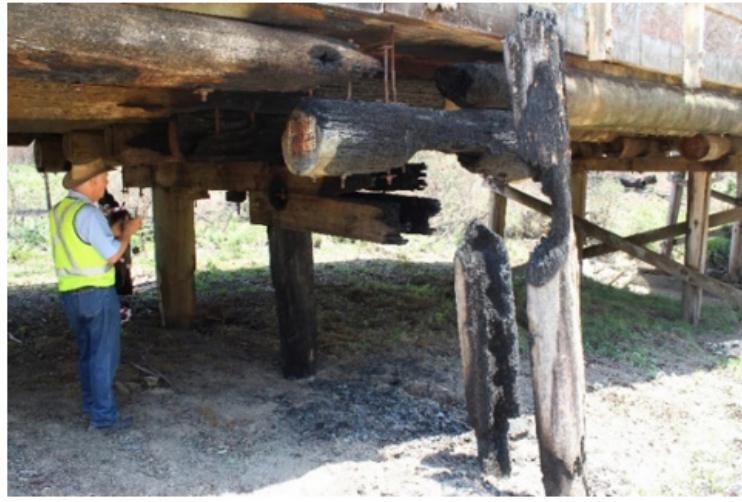
Figure 4: Fire-damaged Clouds Creek Bridge, showing destroyed outer pile, corbel, ends of girders and headstock highlighting end grain progression (Glencross-Grant, 2 January 2020).

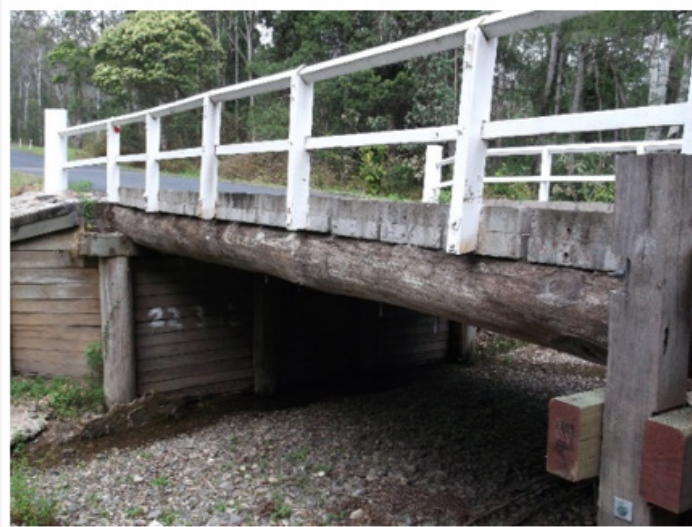
Figure 5: Single span timber Beam Bridge over Hortons Creek (Glencross-Grant, 8 December 2013).

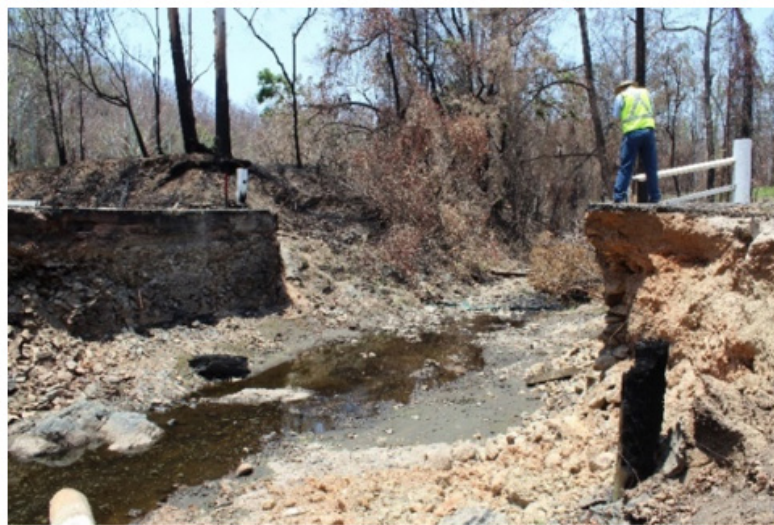
Figure 6: Hortons Creek bridge site, with fire-damaged timber removed (Glencross-Grant, 2 January 2020).
