Research Article

Bathymetric Characteristics of Lake Malombe, Malawi

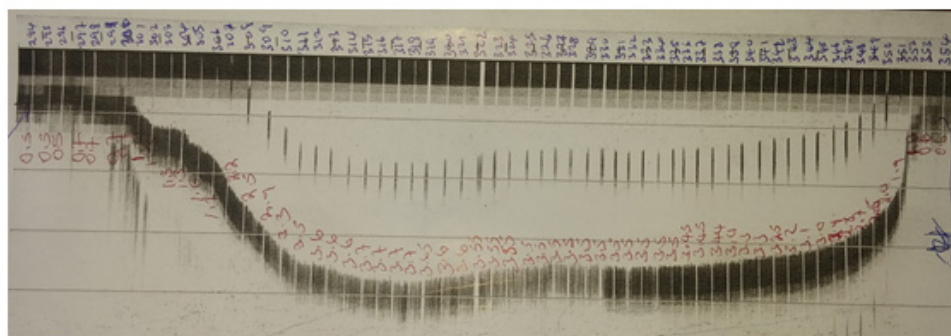
Figure 7: East-West Cross section of Lake Malombe north.

In the northern part of the lake, there is a steep slope in the west decreasing to a gentle slope in the middle followed ending with a gentle slope in the east (Figures 5-7).

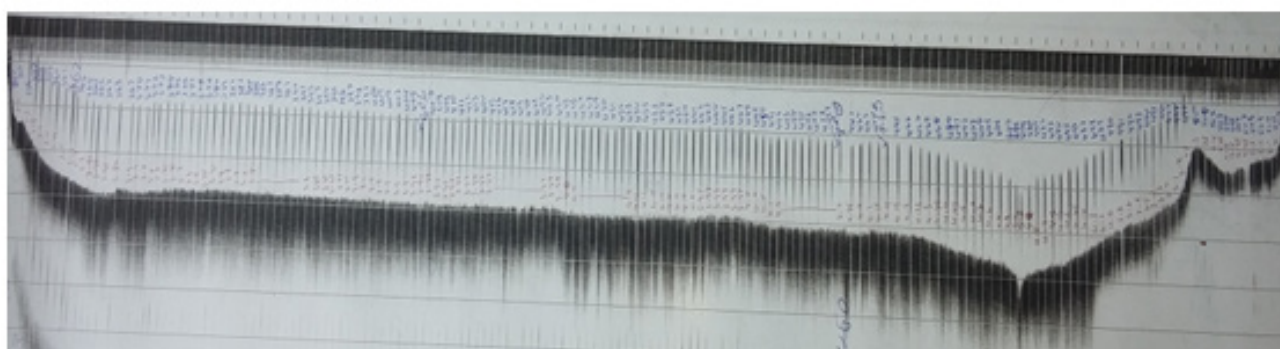
Figure 8: East-West Cross-section of Lake Malombe.

The middle part starts with a steep slope in the west decreasing and has a gentle slope in the middle up to the deepest point. There

is a ridge, a trough and a gentle slope in the middle ending with a steep slope in the east (Figure 8).

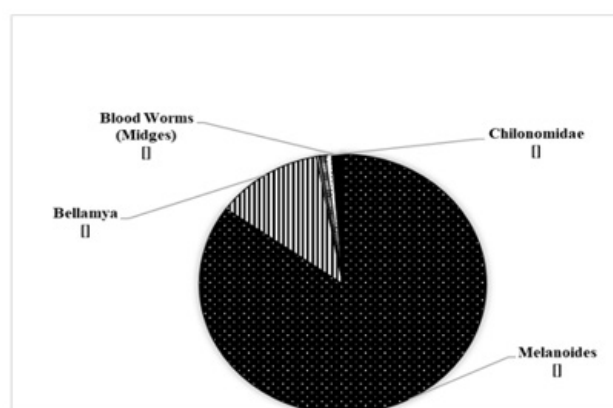
Figure 11: Benthic macro-invertebrates distribution in Lake Malombe.

Figure 11 shows distribution of invertebrates in the benthic portion of the lake.

The *Bellamya capillata* was found to contribute 12% while chironomids larvae contributed only 1%. Thus, Lake Malombe shows great disparities of benthic fauna distribution and abundance.

Results from 35 sampling station in Lake Malombe revealed that snails dominated the zoobenthic invertebrates followed by Diptera larvae, annelids, and black fly larvae. The *Melanoides* were more abundant in the north-western part of the lake. Most invertebrates including tubifex, water beetles and chironomids

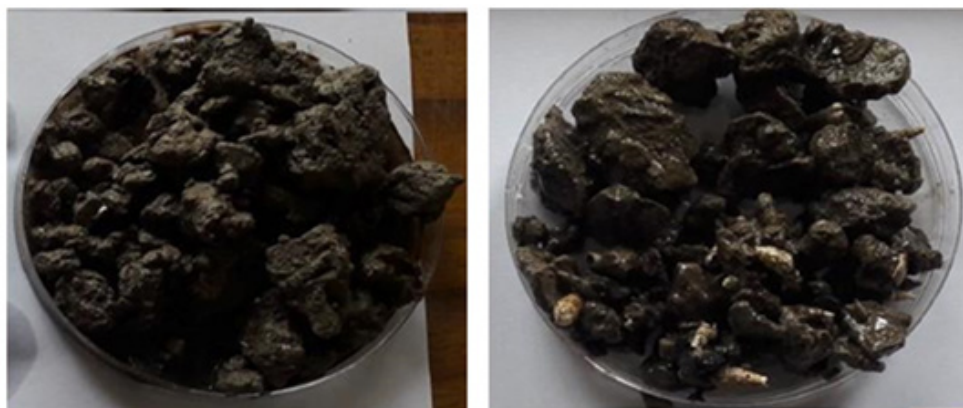
Figure 14: Muddy and dark substrate indicating the presence of decayig zoobenthos.

and debris than other substrates with dead decaying snail shells. Tubifex and blood worms (midges) were more common in substrates with dead decaying snail shells (Figure 14).
