Opportunities to Increase the Reliability of Existing Retaining Walls

Sokolov NS*

Chuvash State University, Russia

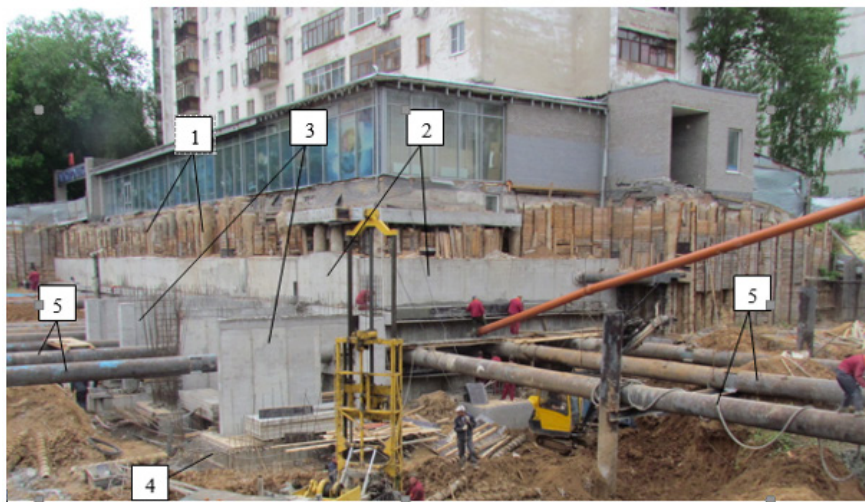
Figure 1: Scheme of fixing the retaining walls of the excavation by shooting from steel pipes 1000 mm: 1-existing bored piles of the excavation fencing; 2-fencing of the pit from monolithic reinforced concrete; 3-mono-ite reinforced concrete buttresses to reinforce the existing retaining wall; 4-monolithic reinforced concrete grillage; 5-existing chimneys - firing to reinforce retaining walls.

In connection with the appearance of an investor, it was decided to erect a completely different building from the one previously planned for construction at this construction site - a ten-storey public facility. At the same time, the designers had to fit into the dimensions of the site in the inner contour of the completed fence made of bored piles (pos. 1, Figures 1 and 3), and also take into account the existing schemes for reinforcing retaining walls using spacer structures made of steel pipes (see pos. 3 on Figures 1 and 3).

decision, it was decided to arrange buttresses (see pos. 3 in Figures 1 and 3), supporting the excavation fence near the residential building through a monolithic reinforced concrete structure (see pos. 2 in Figures 1 and 3), arranged between the existing expansion constructions. The base for monolithic reinforced concrete grillages (see pos. 4 Figures 1 and 4) of the buttresses was proposed to use EDT bored injection piles (pos. 2 Figure 2) in the form of separate bushes for a monolithic reinforced concrete grillage, manufactured using electric discharge technology (ERT technology). The need to use EDT piles with a diameter of 0.35 m and a length of 12.0 to 19.0 m, depending on engineering and geological conditions in one or another part of the construction site, is due to the purpose of ensuring the stability of the buttress against shear from horizontal forces. It was decided to arrange buttresses with grippers: 1. Finished buttress with a set of design strength of all its elements; 2. Dismantling of one steel pipe. In this sequence, the struts are replaced with buttresses. In connection

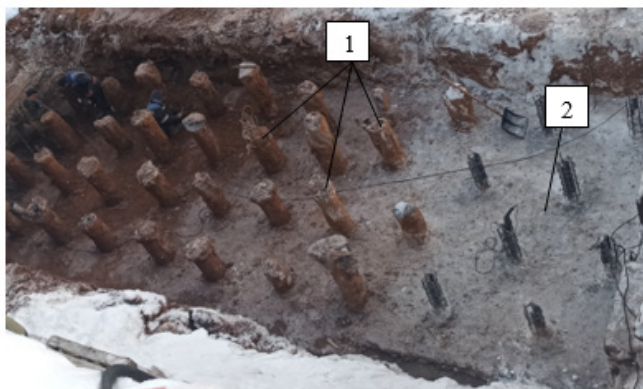
Figure 2: Pile field for a monolithic reinforced concrete buttress: 1-heads of EDT bored injection piles; 2-concrete preparation for grillage.

with the fact that the gap between the pipes was three meters, it was decided to use the drilling rig "Berkut" for the installation of EDT piles (see item 1, Figure 2). To enter it into the annular space, the builders covered it with sand. EDT piles had to be installed in very difficult conditions between the pipes, and the removal of soil from the pit was carried out only manually. It should be emphasized that monolithic reinforced concrete buttresses were the supporting

1	Filling with fine-grained sand of the intertube space
2	Preparation of the site for the installation of ERT piles (pos.2 figure 2) (excavation of the soil, the device of sand and concrete preparations)
3	The arrival of the drilling rig and the construction of the bush of drill injection piles ERT (pos.2 figure 2) under the reinforced concrete rostwerk (pos.4 figures 1, 3) of the monolithic buttress (pos.3 figures 1, 3)
4	Installation of a vertical monolithic reinforced concrete wall on the outside of the drill piles (see poses 2 figures 1, 3)
5	Installation of a monolithic reinforced concrete rostwerk and a buttress with a support on a monolithic reinforced concrete wall (see Pose 2 figures 1 and 3)

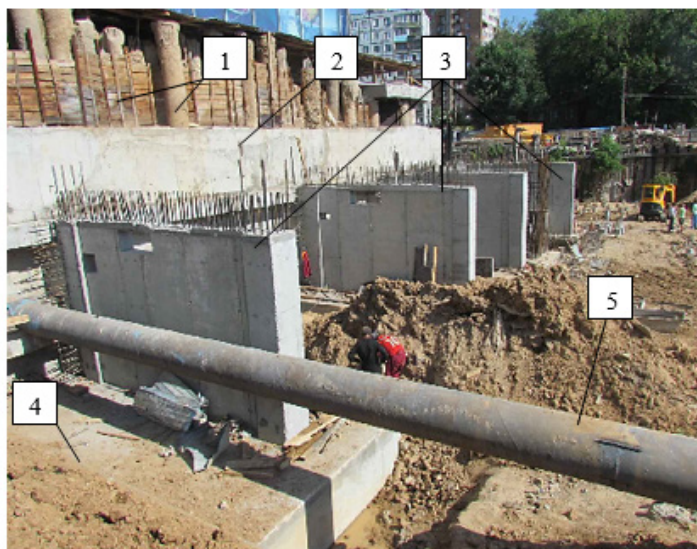
Figure 3: Fragments of the completed monolithic reinforced concrete buttresses: 1-existing bored piles to enclose the excavation; 2-fencing of the pit from monolithic reinforced concrete; 3-monolithic reinforced concrete buttresses to reinforce the existing retaining wall; 4-monolithic reinforced concrete grillage; 5-existing pipe - amplification shooting.

6	After a set of design values of the strength of the concrete of the constituent elements of the buttress, one steel pipe of the spacer structure is disassembled.
Notes:	
The device of the buttresses was made by grippers:	
1	Ready-made monolithic reinforced concrete buttress (pos.3 figures 1 and 3) with a set of design strength of all its constituent elements
2	Disassembly of one steel pipe under the condition of a set of concrete strength of all components of the monolithic buttress
In this sequence, all struts (pos.5 figures 1 and 3) were replaced with monolithic reinforced concrete buttresses (pos.3 figures 1 and 3)
