Spectral Imaging for Stone Surface Investigation: The Case of Horologion of Andronikos Kyrristos In Roman Agora, Athens, Greece

Horologion of Andronikos Kyrristos, also known as the Tower of the Winds, is an octagonal marble building dating from the 1st century B.C., located on the Roman Agora in Athens, Greece. The monument is still in good condition today and as one of the most important masterpieces of late Hellenistic architecture.

The present work refers to the application of modern non-destructive imaging techniques, such as visible, infrared and thermal imaging and symmetrical and raking light, in order to collect data useful for solving conservation problems and to document the different historical phases of the monument. The study focused on investigating the stone surface and decoration and on detecting color traces, engravings, graffiti and inscriptions associated with its historical phases and its use until more recent years. The research was carried out on all the interior surfaces of the building as well as on the upper zone exterior sculptures. Useful information regarding conservation status, surface morphology and archaeological history were extracted.

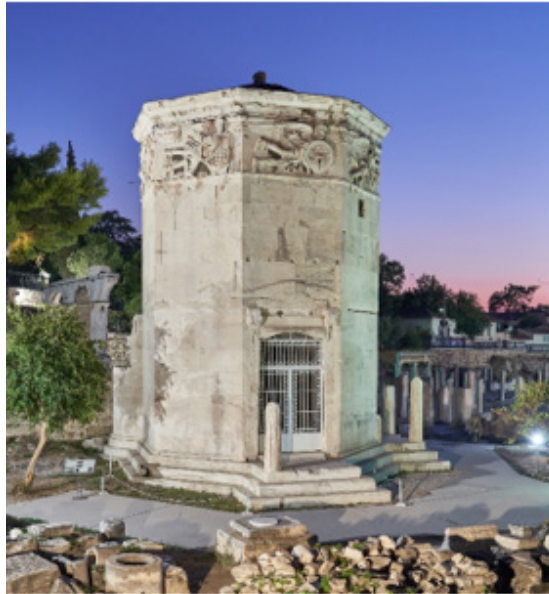
Figure 1a: Left: Horologion in the Roman Agora [18].

Horologion of Andronikos Kyrristos is an octagonal marble building, located on the Roman Agora in Athens, Greece (Figures 1a & 1b). Different opinions about the date of construction can be found referring to either around 47 B.C. or, by some others, around the second century B.C. [1]. It is also known as the Tower

of the Winds because its exterior upper zone is adorned with eight sculptures, each representing a different wind deity, one on each side wall of the octagon, that bear the name of the wind of the corresponding orientation: Boreas (North), Notos (South), Apeliotes (East), Zephyros (West), Kaikias (northeast), Evros (southeast), Lips (southwest) and Skiron (northwest).

The monument is still in good condition today and attracts particular interest as one of the most important masterpieces of late Hellenistic architecture. The monument's height reaches 13.5m and its maximum diameter is 8m. There is a semicylindrical annex attached on its south side. Andronikos from Kyrros, a town in Macedonia, was an astronomer who made good use of the era's science and technology and manufactured a mechanism that could indicate the time and other meteorological information [2,3]. Marks on the outer walls formed sundials for the sunny days, while a hydraulic mechanism inside the monument would be put to use on

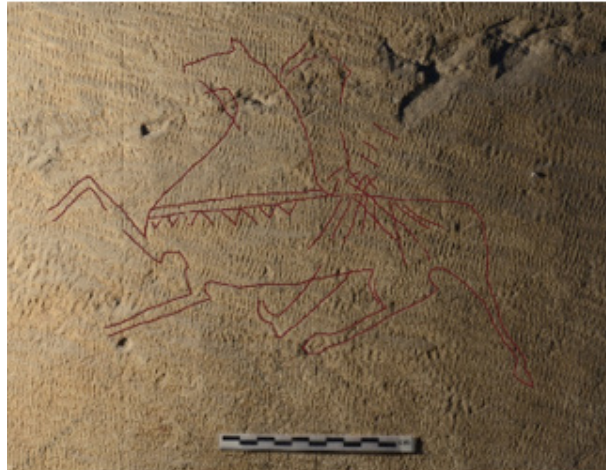
Figure 3: Evros wall (SE), stone 344. VIS, raking light. (a) Left: the figure of a deer. (b) Right: the figure of a horse and rider. Both images have been digitally processed to highlight the outline of each figure in red color.

The study of the engraved images revealed the figure of a deer, a horse and his rider and parts of at least two ships. The figure of the deer is elegant, its feet risen in gallop, its head adorned with antlers (Figure 3a). At first, it was thought that the outline of a horse was seen but after careful study of the engraved lines, the form of a rider's leg was discerned. The horse is decorated with a zig-zag strap. The rider wears a long cloth. No upper body or head could be

distinguished (Figure 3b). The style the two animals were created i.e., the curve of the front necks and the angles of the front and back legs indicate that it might have been the same artist who created them. Furthermore, their proximity, the deer being left of the horse and rider and the fact that all of them face left, could indicate that they belonged together and were part of a hunting scene.

In the case of both the hunting scene and the ships' figures, after the acquisition of the images, mathematical processing was applied and, in high magnification, the engraved images were traced manually, under high magnification, with the brush tool of Photoshop.

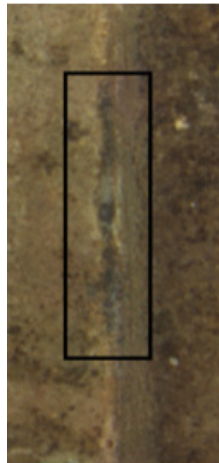
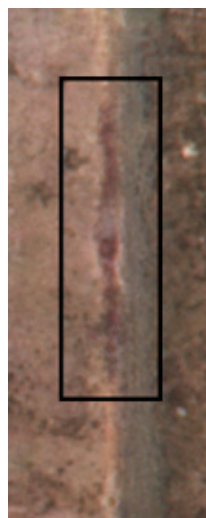
Figure 7: Zephyros wall (W), stone 187. Macro photos of a console. (a) left: VIS and (b) right: IRFC, where the purple false color of Egyptian blue can be observed.

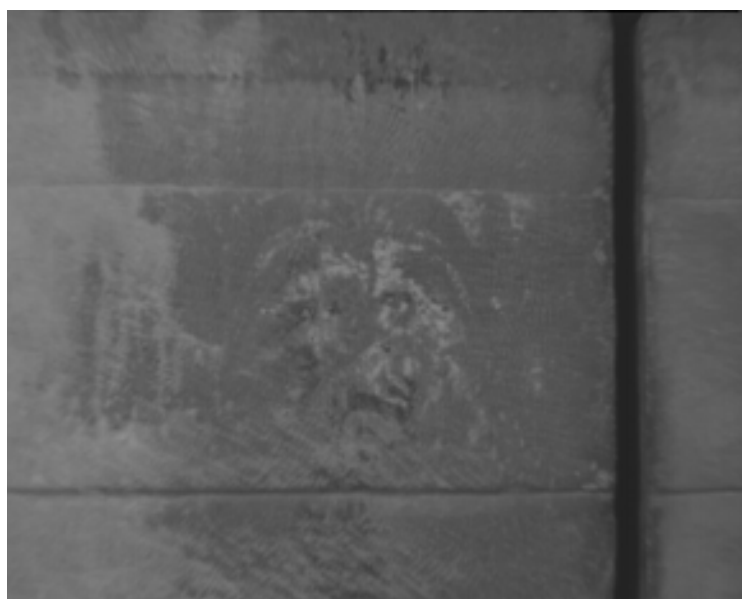
Figure 9: Zephyros wall (W), stone 47. (a) Left: b&w image. (b) pseudo color image. While the vertical gap between the stones is visible, no trace of incoming humidity can be observed.

recorded and some of them presented distorted images, indicating either their displacement and/or the existence of humidity. In the case of stones [47-48] (Figure 9a & 9b), the gap between the stones is visible but the important information the thermal image provides is that both stones are in a rather good condition (green, yellow colors), without humidity or water inflow having affected them, as it would have shown as blue-black color. In the case of stones covered with mortar, such as stone 199 (Figure 10a & 10b), in the visible the condition of the material is not clear – there may be successive layers. However, looking at the thermal image, it is evident that the mortar has deep cracks depicted by dark blue color. On the other side, stones like 256, surrounded by 257 on its left and 279 under it, present a perfect condition (Figure 11a & 11b). The joints are almost not observed indicating not only the quality of the artisans who placed them but also the lack of any signs of humidity. In this example, it must be noted that a black paint inscription is also observed producing a deep blue color. One could argue that its absorption could be strong enough to diminish the existence of humidity signs between the stones. However, this is not the case, because for each recording local calibration takes place and such an anomaly would have been noticed. In this case, the deep blue color refers to the absorption of the infrared radiation by the specific pigment. Furthermore, in cases of humidity existence, the extreme lack of heat always shows as dark blue color. A good example is the black color of the ottoman inscription. The joints of the stones bearing the inscription (stones 256, 257, 25, 259, 260) present humidity as dark blue, so the inscription is depicted by dark blue, light blue and green. This can be observed on all stones that bear the black ottoman inscription (Figure 11b & 12b). The black used for the writing shows consistently high absorption in the infrared indicating a carbon black or bone black material [47].

the extent of the area of deterioration, as seen in stones 47 (Figure 9a & 9b) and 258 (Figure 12a & 12b). In this case, the yellow, red, and white colors depict the areas affected. The lighter the color the more severe the deterioration of the material. In the visible and infrared images, the deterioration can be easily detected but it is with the help of the thermographic camera that the severity of the phenomenon and its actual extent can be observed and recorded.

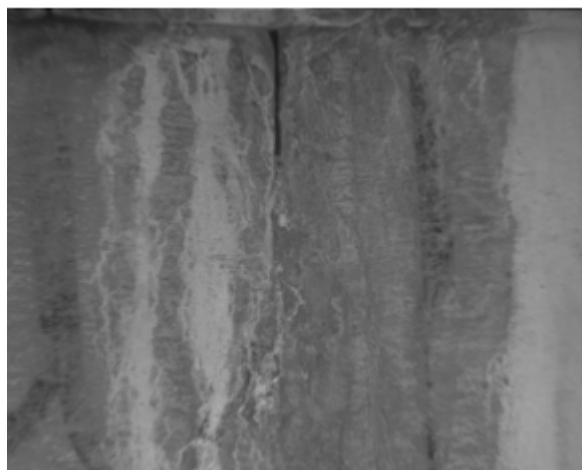
Figure 12: Notos wall (S), stone 258. (a) Left: b&w image. (b) pseudo color image. The severity and extent of the humidity on the wash off on the stone is clearly observed.

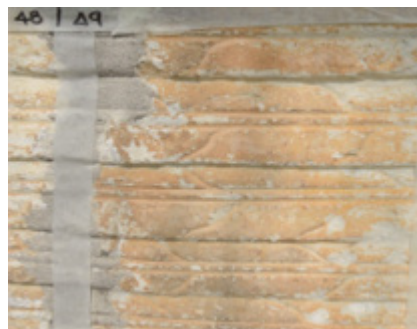
Figure 13: Zephyros wall (W), exterior stone 48/Δ9. (a) visible, (b) 460nm and (c) 1000nm.

The orange color found on the sculptures of Horologion produces fine images. In the visible, the Epidermis on the Horologion marbles has a light orange color (Figure 13a, 14, 15a). The images at 460nm present areas of high absorbance where the patina is formed, enabling the recording of the boundaries and extent of this phenomenon more accurately (Figure 13b & 15b). On the other hand, in the infrared, the Epidermis is highly transparent. Apart from pigments that reflect infrared radiation such as cinnabar, most pigments and especially earth pigments that might have been employed for the decoration of the monument usually have high absorption in the infrared region [47]. However, in this case, the transparency of the layer proves that it regards to Epidermis and not a paint layer containing iron based or earth pigments. At 1000nm, in all areas that were examined, the marble is depicted in a very fine white tone with high reflectivity (Figure 13c & 15c). Traces of pitting of the material are visible thus helping in a more in depth validation of the condition of the marble. The relief decoration of the areas was highlighted and could be observed more easily. Further chemical analysis is need to verify the existence of calcium oxalate and traces of pigment on the sculpture.

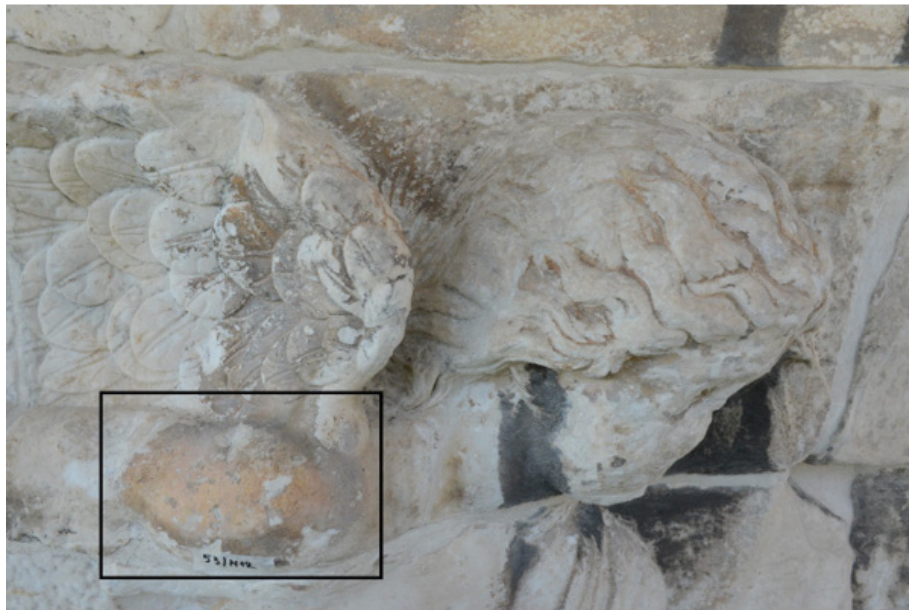
Figure 14: Apeliotes wall (E), exterior stone 53/N12. VIS, Sculpture of Wind Deity Apeliotes, the east wind, who brings a gradual gentle rain.

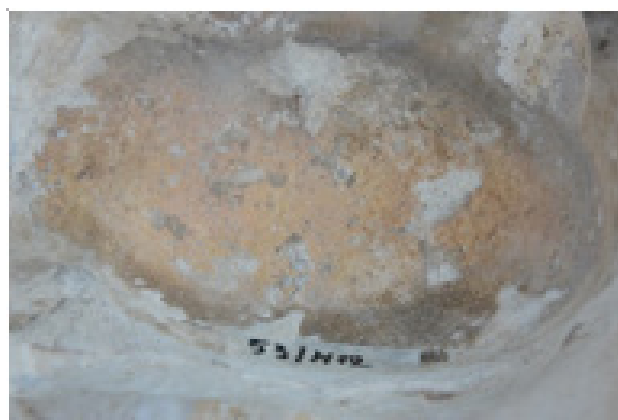
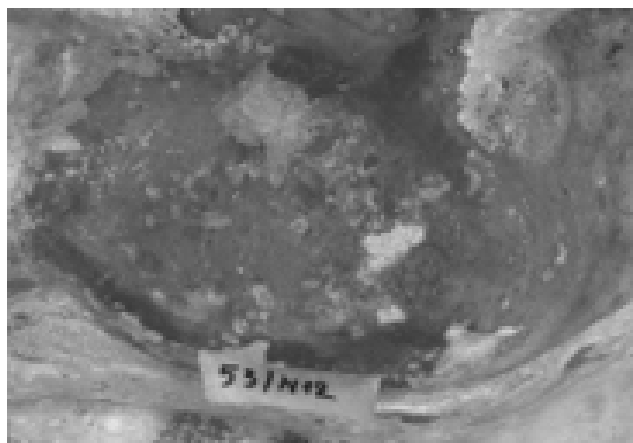
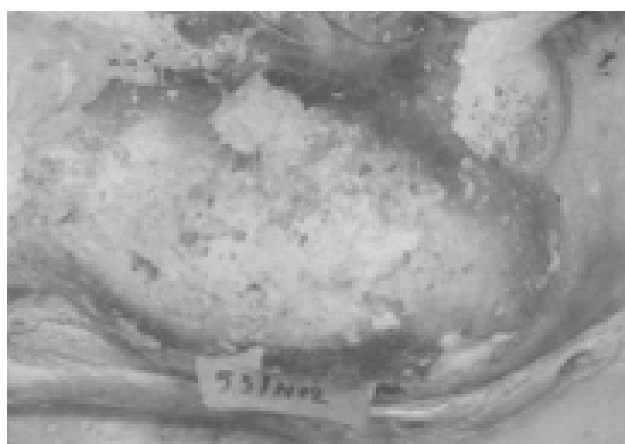
Figure 15: Apeliotes wall (E), exterior stone 53/N12. Sculpture of Wind Deity Apeliotes, the east wind, who brings a gradual gentle rain. Detail of the shoulder (a) VIS, (b) 460nm and (c) 1000nm.
