Soil and Water Conservation Measures in Ethiopia: Importance and Adoption Challenges

Negessa Gadisa^{1*} and Tesfaye Midega²

Ethiopian Institute of Agricultural Research, Holeta Agricultural Research Center

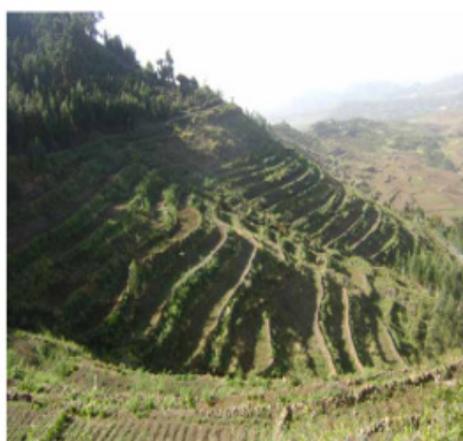
Figure 1: Bench terrace in Tigray.

A bench terrace is a conservation structure where a slope is converted into a series of steps, with a horizontal cultivated area on the step and steep risers between two steps (Figures 1 and 2). In Ethiopia, a bench terrace is usually developed from bunds and Fanya Juus over a period of 5–15 years through careful maintenance and buildup [18]. Bench terraces are level along the contour in dry to moist agroecological zones. In moist to wet agroecological zones, they are graded to drain excess runoff sideways to the next river or waterway. Levelling the cultivated land will greatly reduce soil erosion, usually to tolerable amounts.

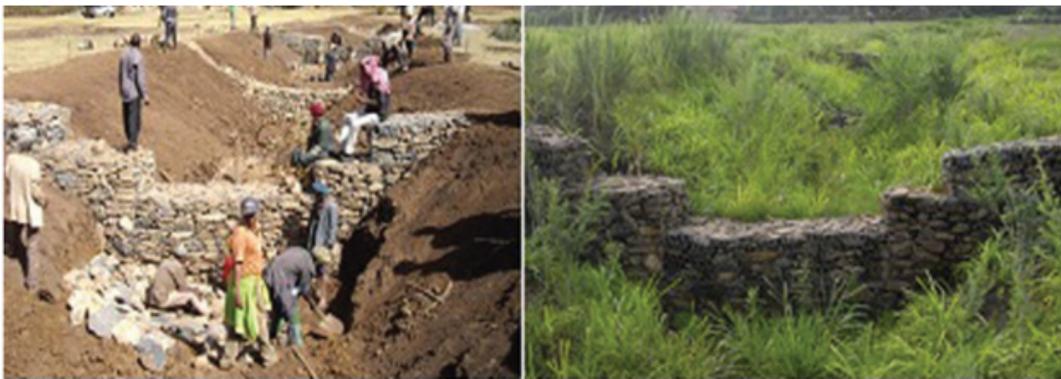
Figure 3: Check dam.

A check dam is an obstruction wall across the bottom of a gully or a small river to reduce the velocity of the runoff and prevent deepening or widening of the gully and help to fill it up with sediment (Figure 3). The potential energy is absorbed below the vertical drops of the over-fall. Sediments are deposited behind the check dams so that the slope gradient of the gully is also reduced.

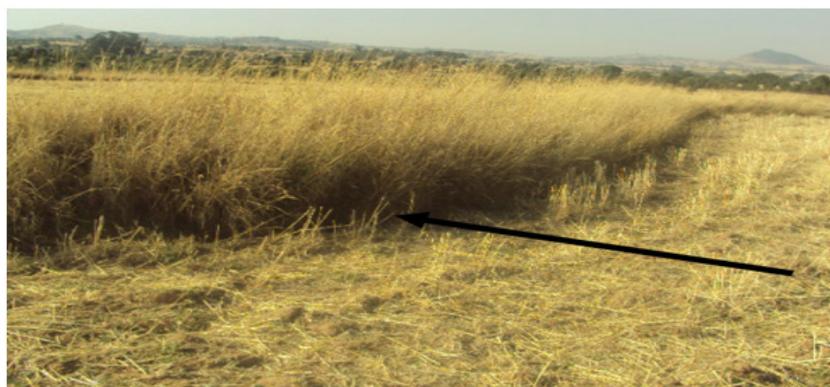
Figure 4: Grass strip.

A grass strip is a ribbon-like band of grass laid out on cultivated land along the contour. Grass Strips help to reduce runoff and to filter out sediments carried by runoff (Figure 4). They are especially suitable on soil with good infiltration on gentle slopes and where the climate is not too dry for dense grass development.
