Research Article

Comparison of Physical Properties of Purl- and Rib Structures Produced in a Hand-Driven V-Bed Rib Knitting Machine

Keywords: Purl fabric; V-Bed rib machine; Manual loop transfer technique; Rib structures; Physical characteristics

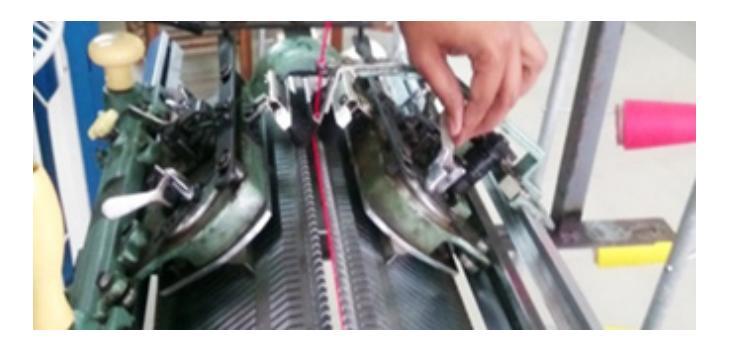
Figure 1: Front bed deactivated, and back bed activated by cam selector.

Once the first course is produced, the front bed is deactivated, and the back bed is activated. Using a loop transfer element, the loops are transferred from the front bed to the back bed. The carriage is moved from one end to the other end of the bed to produce the second course. This procedure has been repeated until all the courses are produced, and hence, 1x1 purl fabric is achieved (Figures 1 & 2).

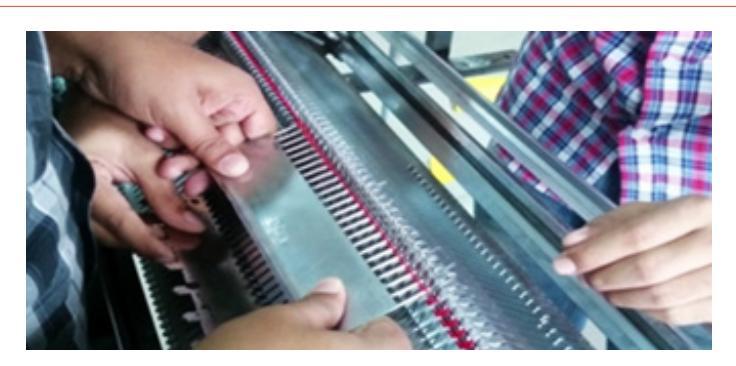
Figure 2: Loops transferred from back bed to front bed.

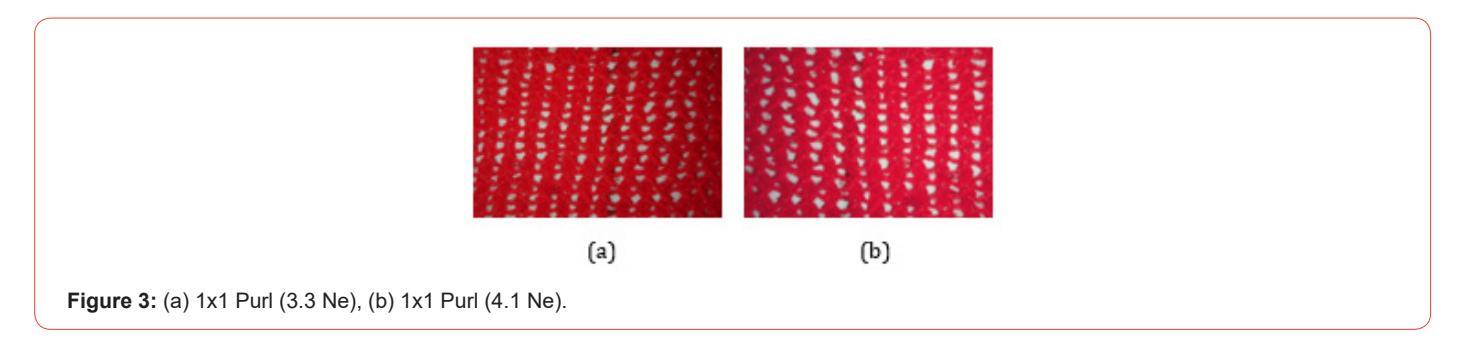
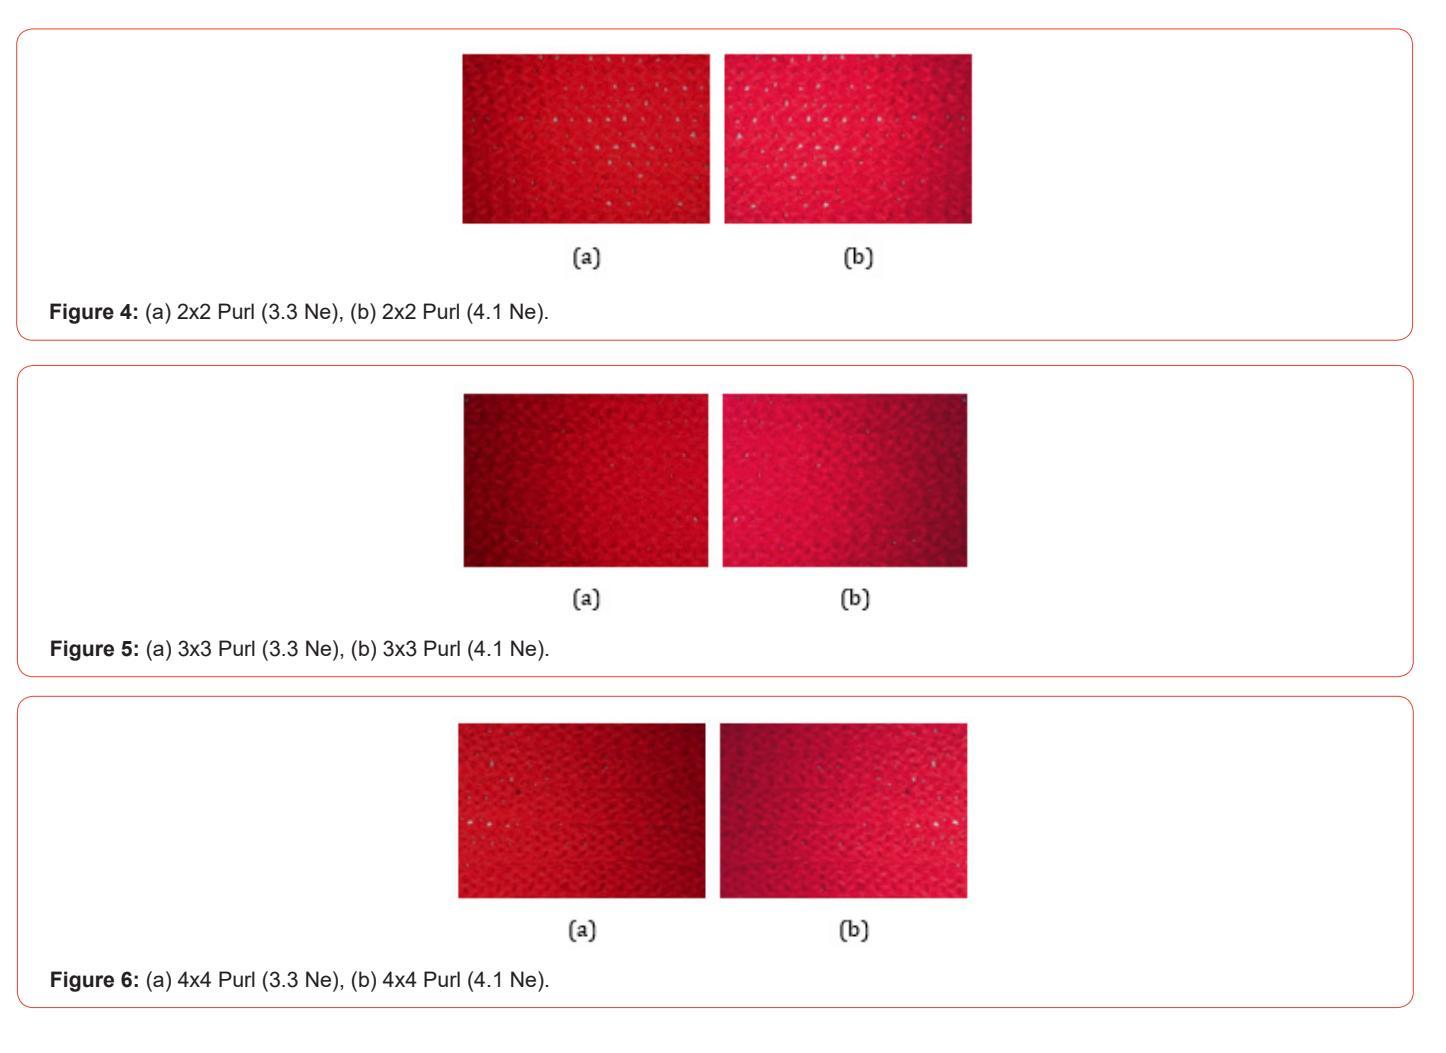
Similarly, for producing 3x3 and 4x4 purl fabric, the same procedure has been followed. However, the carriage is driven three times for 3x3 purl fabric and four times for 4x4 purl fabric. By this procedure, purl fabric can be successfully produced in the V-Bed rib knitting machine (Figure 3-6).

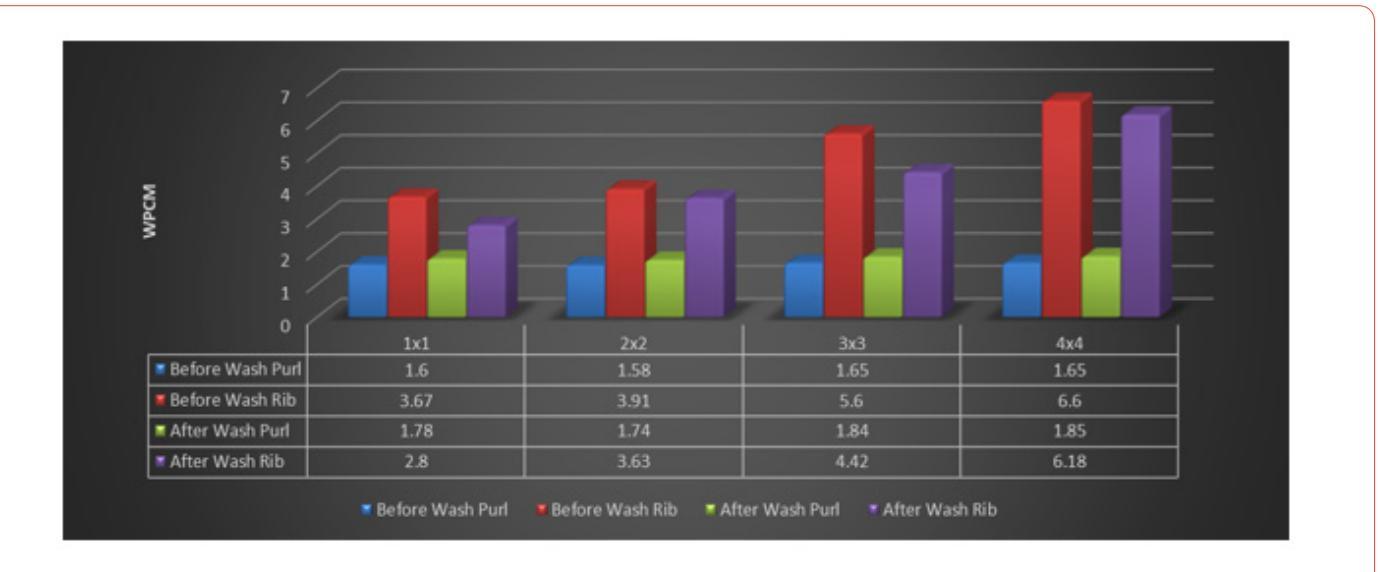
Comparison of wpcm between purl and rib structures before wash & after wash: The data presented in Figures 7 and

8 illustrate that for both 3.3 Ne and 4.1 Ne yarn counts, the WPcm of 1x1 purl structure was lower than that of 1x1 rib structure in both pre-wash and post-wash conditions. The same pattern was observed for 2x2 purl and rib, 3x3 purl and rib, as well as 4x4 purl and rib structures.

Figure 7: Comparison of WPcm between Purl and Rib Structures (3.3 Ne).

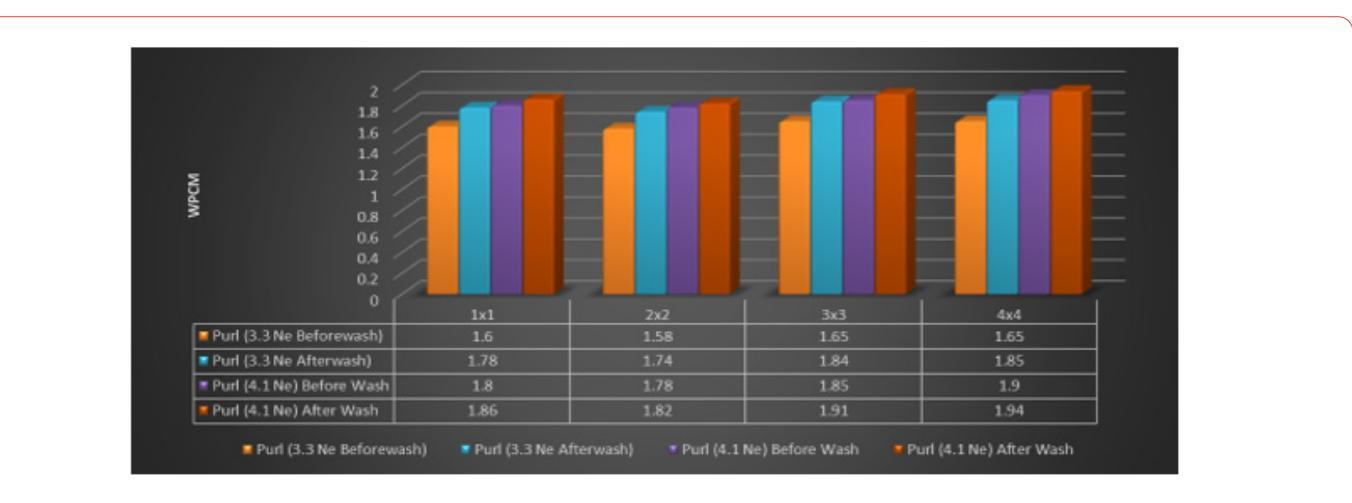
Comparison of wpcm between purl structures before wash & after wash: Figure 9 shows a clear increase in WPcm for 1x1 purl structures after washing. This trend was also observed for 2x2 purl, 3x3 purl, and 4x4 purl structures produced from both 3.3 Ne and 4.1 Ne acrylic yarn. Prior to washing, the WPcm values for 1x1 purl structures were lower than those after washing.

Figure 9: Comparison of WPcm between Purl Structures (3.3 Ne & 4.1 Ne).

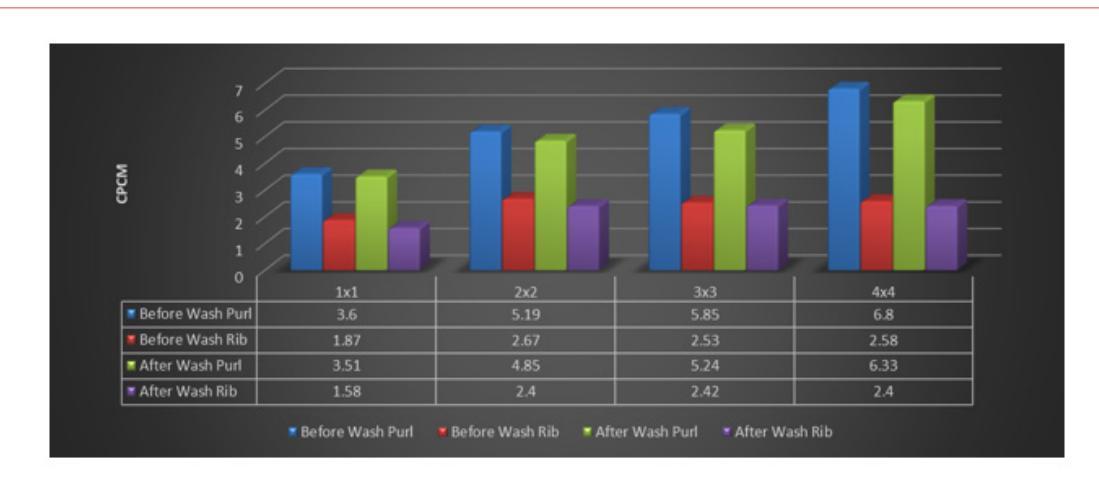
Figure 10: Comparison of CPcm between Purl and Rib Structures (3.3 Ne).

Comparison of CPcm between Purl and Rib structure before wash & after wash: The data presented in Figures 10 and 11 demonstrate that for both 3.3 Ne and 4.1 Ne yarn counts, the CPcm of 1x1 purl structure was higher than that of 1x1 rib structure in both pre-wash and post-wash conditions. This trend was also observed for 2x2 purl and rib, 3x3 purl and rib, as well as 4x4 purl and rib structures. **Comparison of CPcm between purl structures before wash and after wash:** According to Figure 12, there was a clear decrease in CPcm for 1x1 purl structures after washing, for both 3.3 Ne and 4.1 Ne yarn counts. This trend was also observed for 2x2 purl, 3x3 purl, and 4x4 purl structures. Prior to washing, the CPcm values for 1x1 purl structures were higher than those after washing.

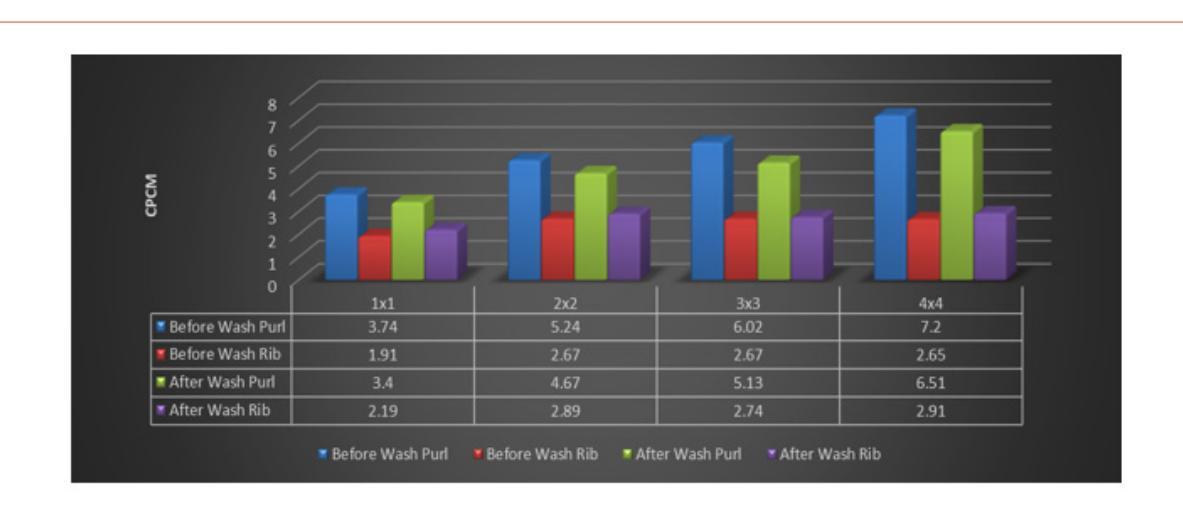
Figure 11: Comparison of CPcm between Purl and Rib Structures (4.1 Ne).

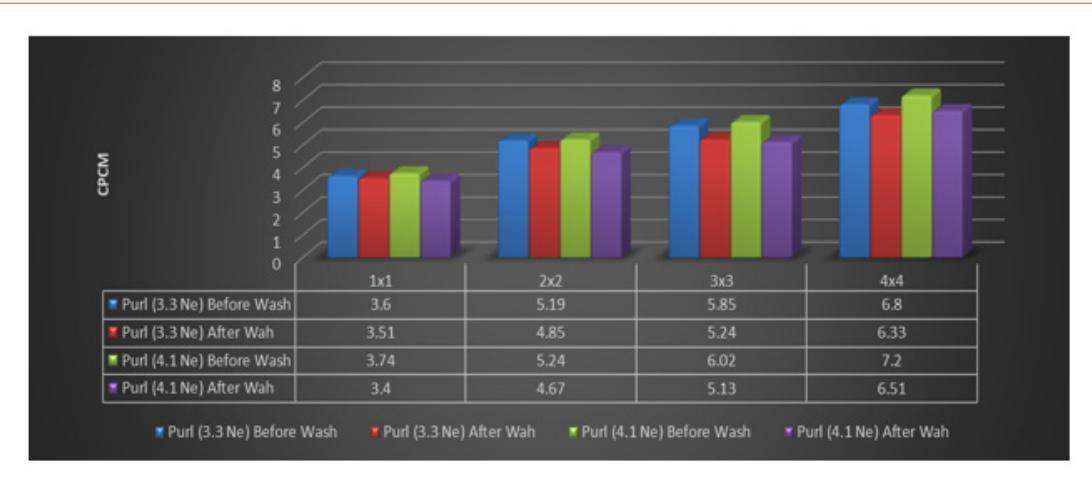
Figure 12: Comparison of CPcm between Purl Structures.

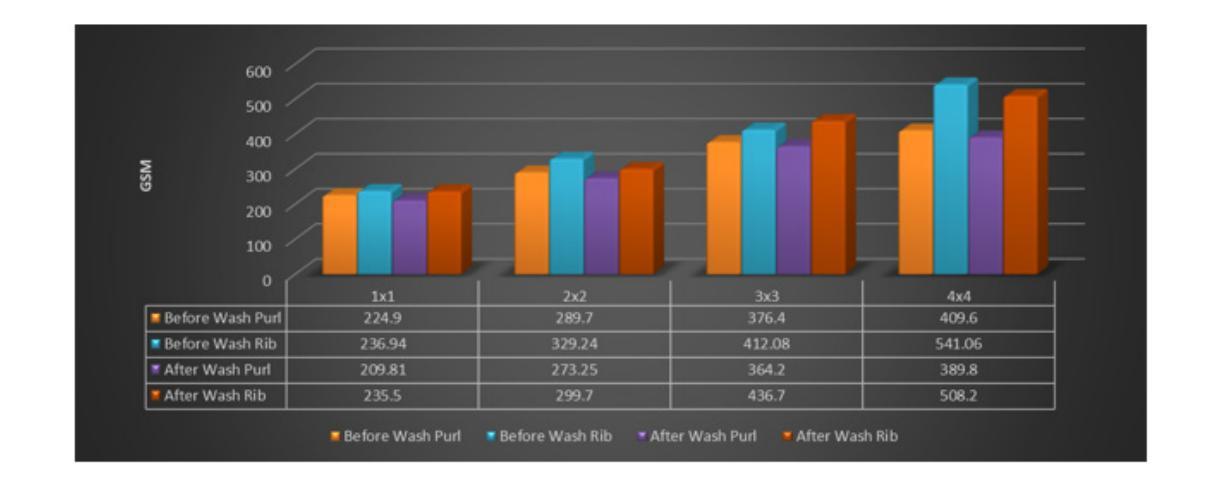
Comparison of GSM between Purl and Rib Fabric before wash & after wash: The Figures 13 and 14 indicate that for fabrics made from both 3.3 Ne and 4.1 Ne yarn counts, 1x1 rib structures exhibited a higher GSM than 1x1 purl structures in both pre-wash and post-wash conditions. This trend was also observed for 2x2 purl and rib, 3x3 purl and rib, as well as 4x4 purl and rib structures.

Figure 13: Comparison of GSM between Purl and Rib Structures (3.3 Ne).

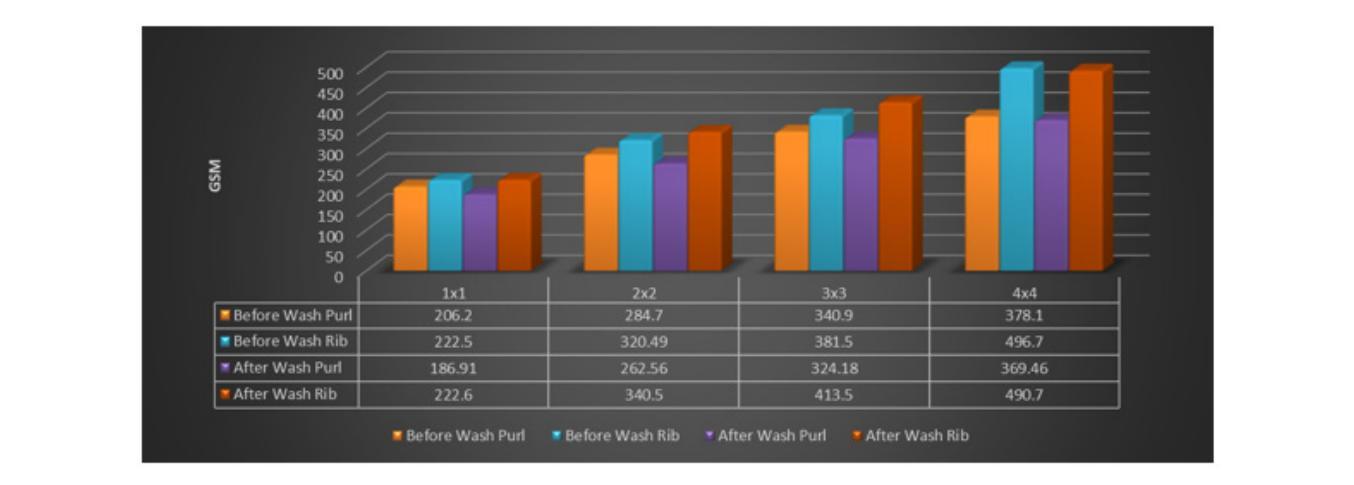
Figure 14: Comparison of GSM between Purl and Rib Structures (4.1 Ne).

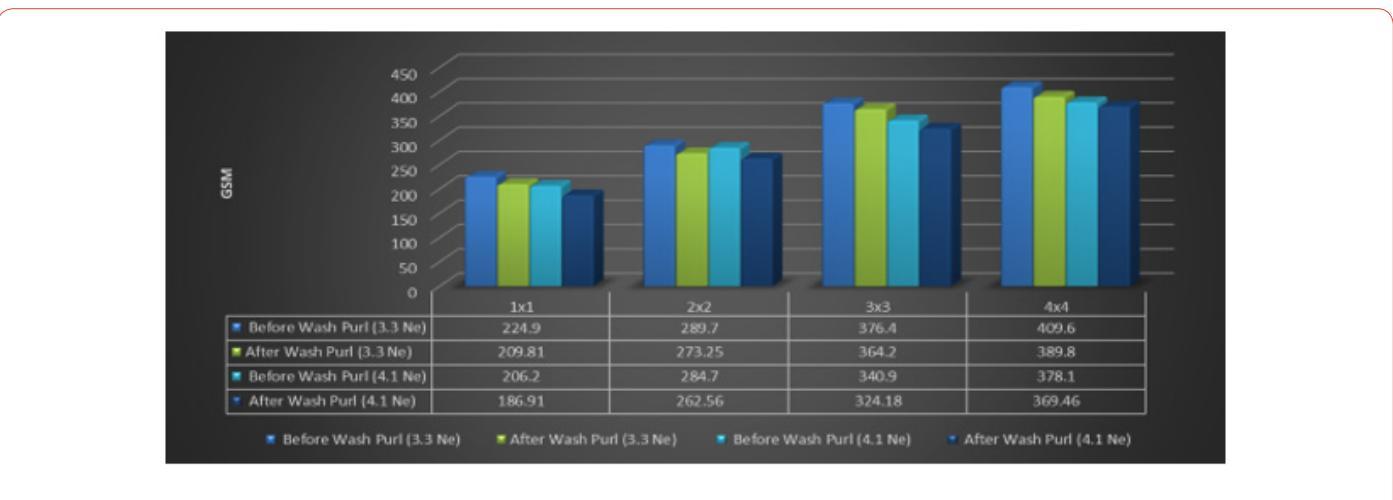
Comparison of GSM of Different Purl Structures: Figure 15 shows that prior to washing, the GSM of 1x1 purl structures, for both 3.3 Ne and 4.1 Ne yarn counts, were higher than those of post-

washed 1x1 purl structures. The same trend was observed for 2x2 purl, 3x3 purl, and 4x4 purl structures.

Figure 15: Comparison of GSM between Purl Structures.

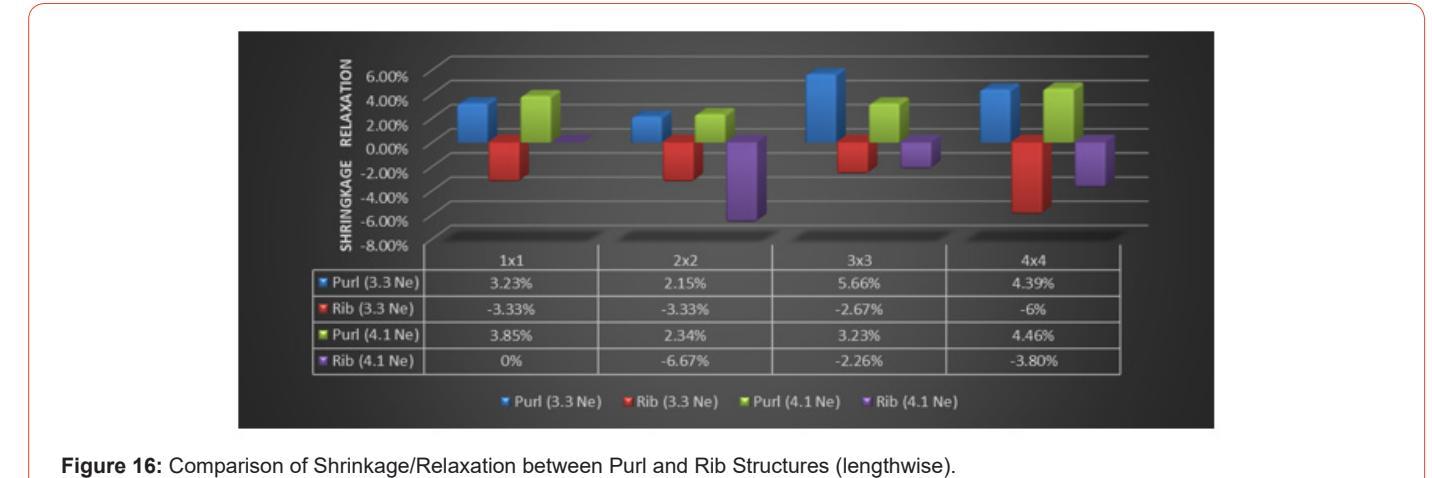
Comparison of lengthwise shrinkage or relaxation: Based on the findings presented in Figure 16, purl- and rib fabrics made from the same yarn count exhibited different behaviors after

washing. Specifically, purl structures exhibited relaxation, while rib structures exhibited shrinkage. This is attributed to the greater lengthwise extensibility of purl structures.

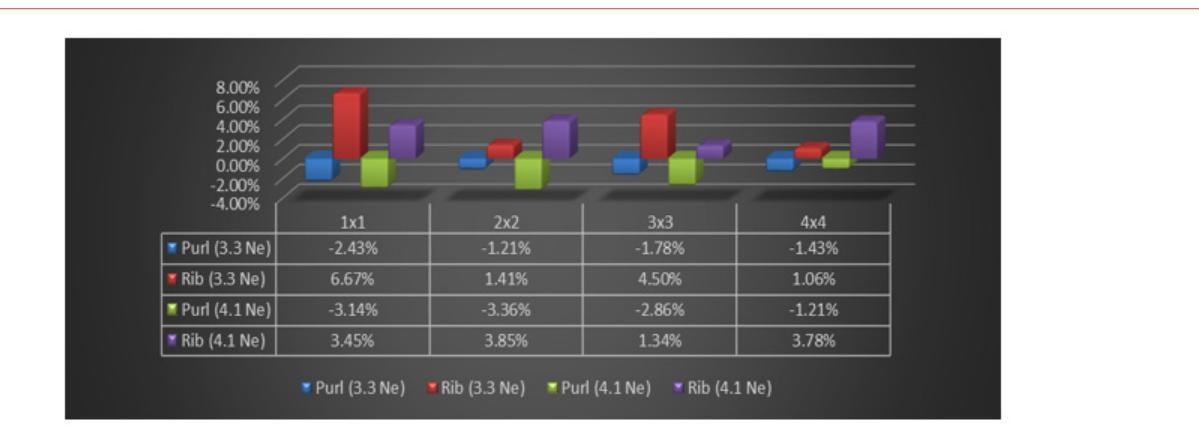
Comparison of widthwise shrinkage or relaxation: Based on the results presented in Figure 17, it is clear that after washing, fabrics made from the same yarn count showed different results. Rib

derivatives exhibited relaxation, while purl derivatives exhibited shrinkage. This is attributed to the widthwise extensibility of rib structures.

Figure 17: Comparison of Shrinkage/Relaxation between Purl and Rib Structures (widthwise).

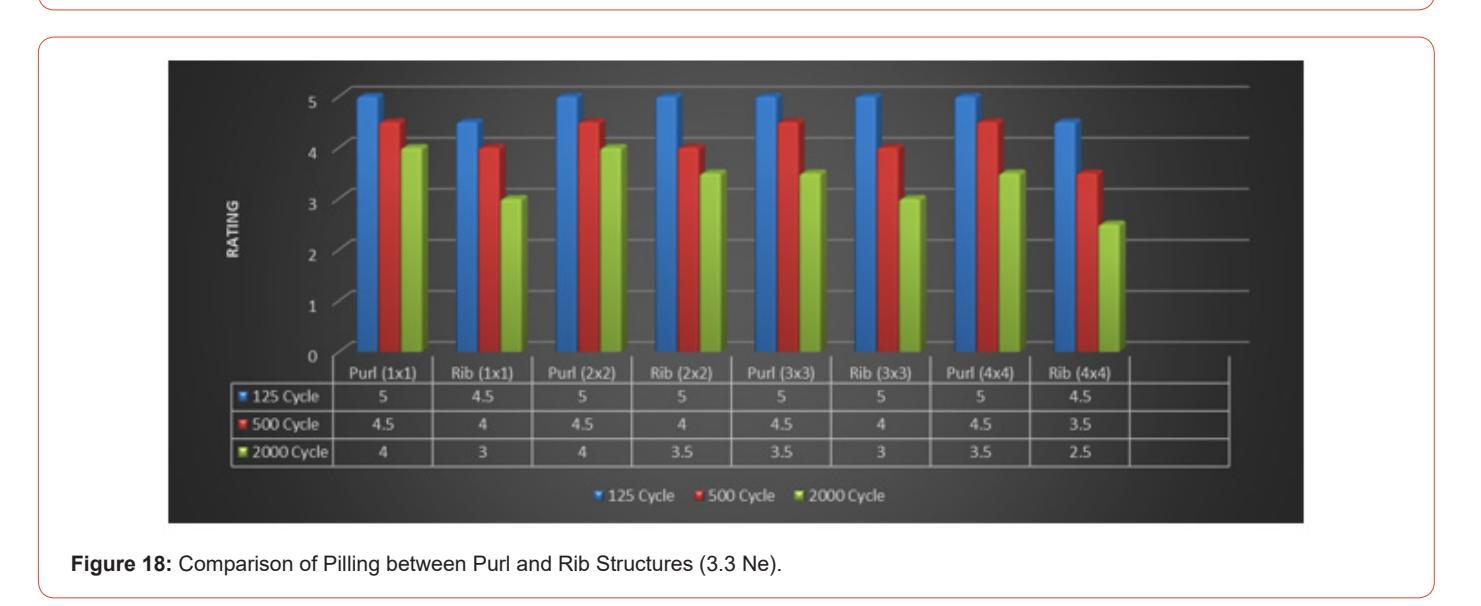
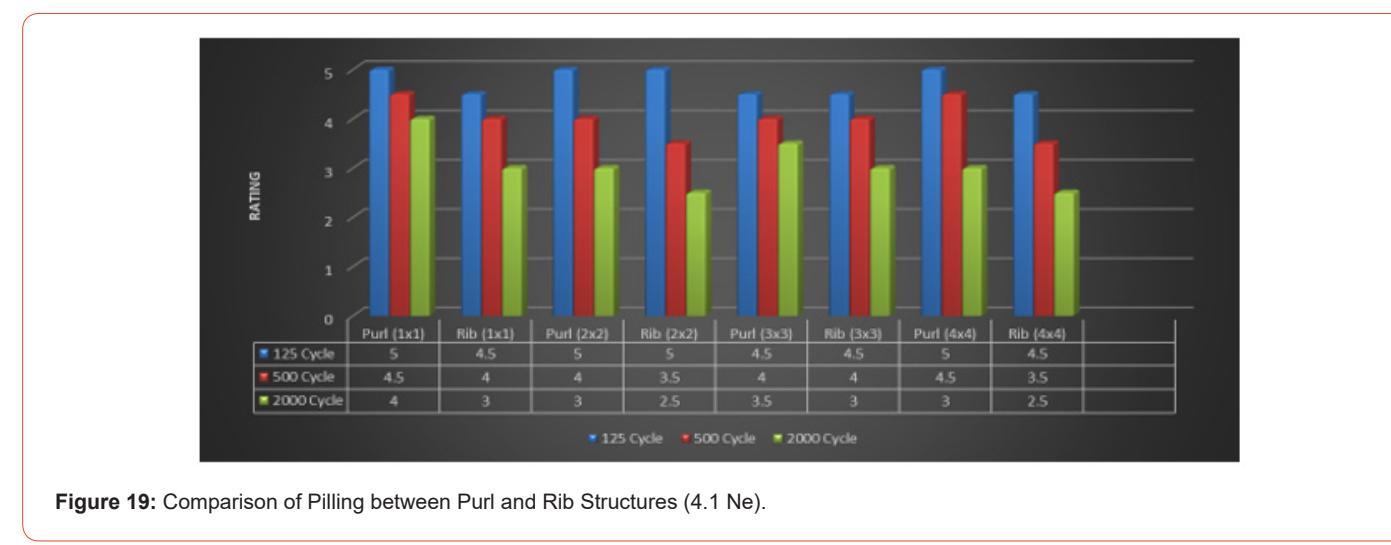
Comparison of pilling between purl and rib structures before wash: Based on the findings presented in Figures 18 and 19, it is clear that before washing, pilling was lower in 1x1 rib structures (for both yarn counts of 3.3 Ne and 4.1 Ne) compared to 1x1 purl structures. This trend was also observed in other structure types, such as 2x2 purl and rib, 3x3 purl and rib, and 4x4 purl and rib.

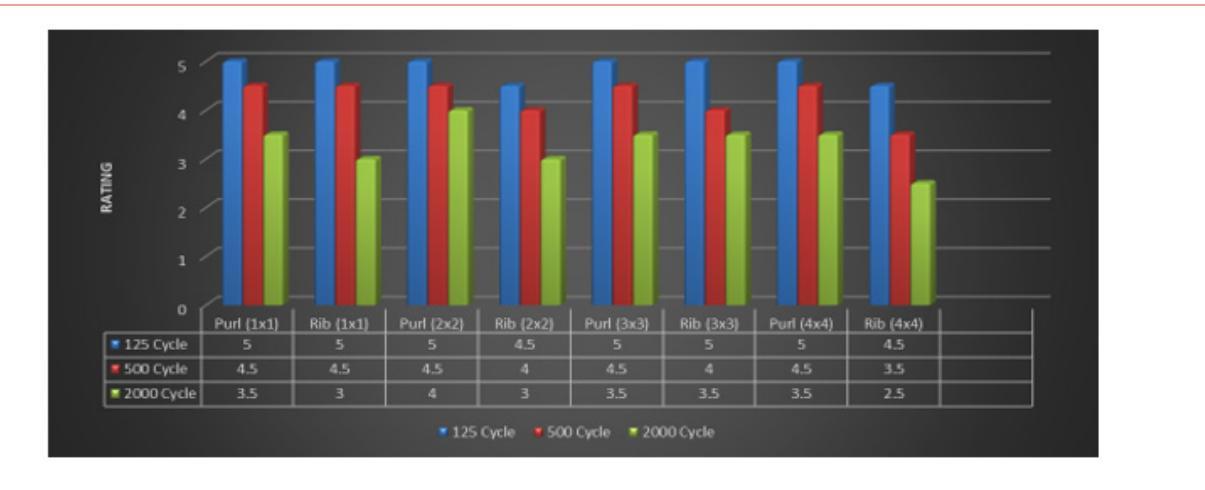
Comparison of pilling between purl and rib structures after wash: According to the findings presented in Figures 20 and 21, it is clear that after washing, pilling in 1x1 rib structures (for both yarn counts of 3.3 Ne and 4.1 Ne) was either equal to or lower than pilling in 1x1 purl structures. This trend was also observed in other structure types, such as 2x2 purl and rib, 3x3 purl and rib, and 4x4 purl and rib.

Figure 20: Comparison of Pilling between Purl and Rib Structures (3.3 Ne).

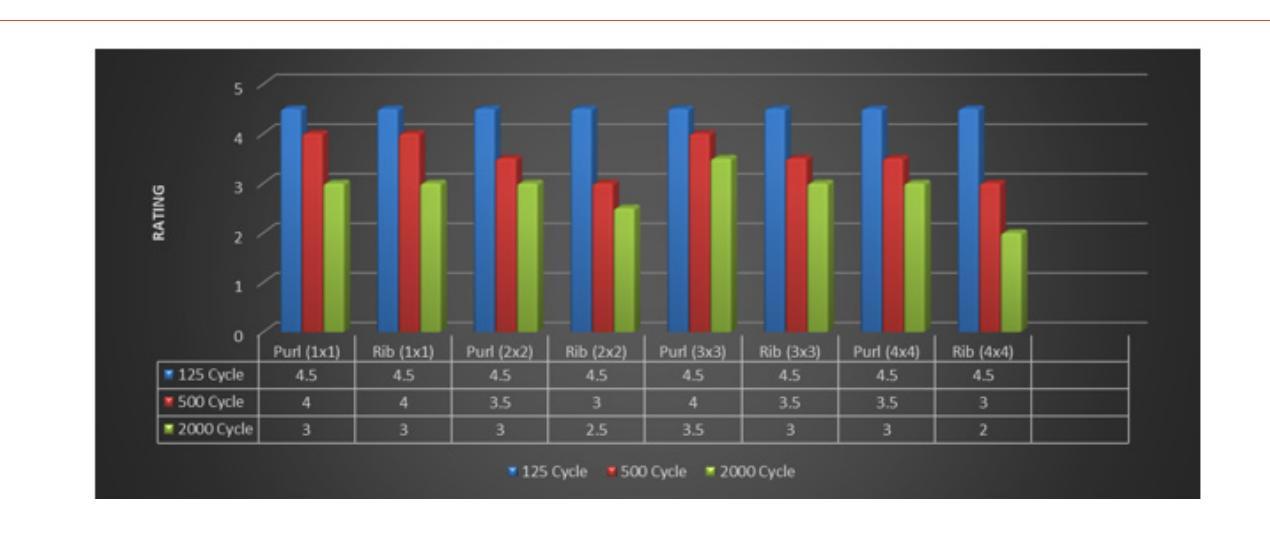
Figure 21: Comparison of Pilling between Purl and Rib Structures (4.1 Ne).

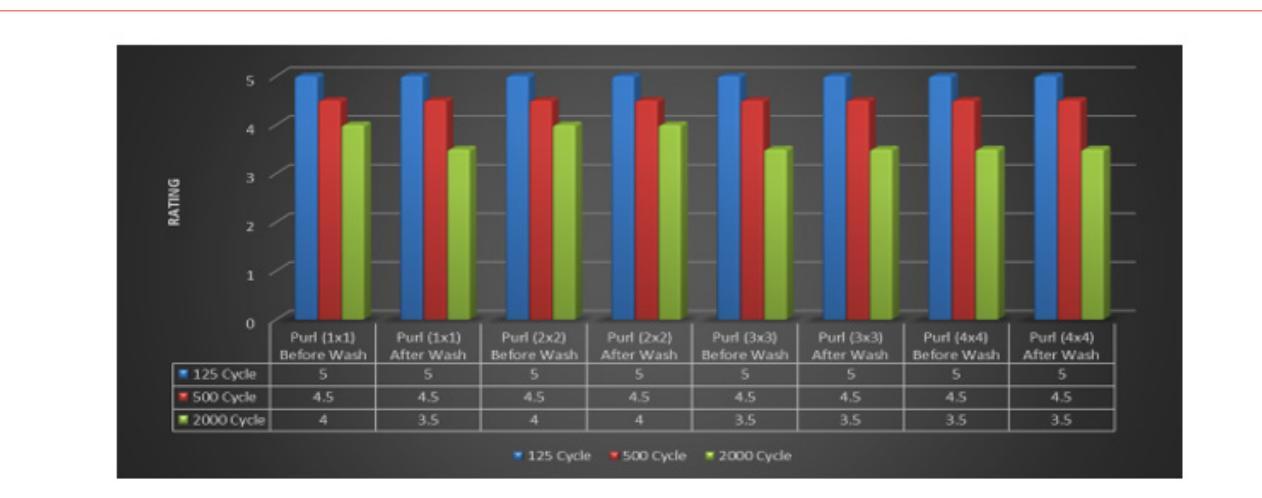
Comparison of pilling between purl structures: Based on Figures 22 and 23, it is apparent that the pilling of 1x1 purl structures (for both yarn counts of 3.3 Ne and 4.1 Ne) after washing

was either equal or lower than the pilling of 1x1 purl structures before washing. This pattern was similarly observed for 2x2 purl, 3x3 purl, and 4x4 purl structures.

Figure 22: Comparison of Pilling between Purl Structures (3.3 Ne).
