Research Article

Gully Erosion and Landslides in Southeastern Nigeria: Causes, Consequences and Control Measures

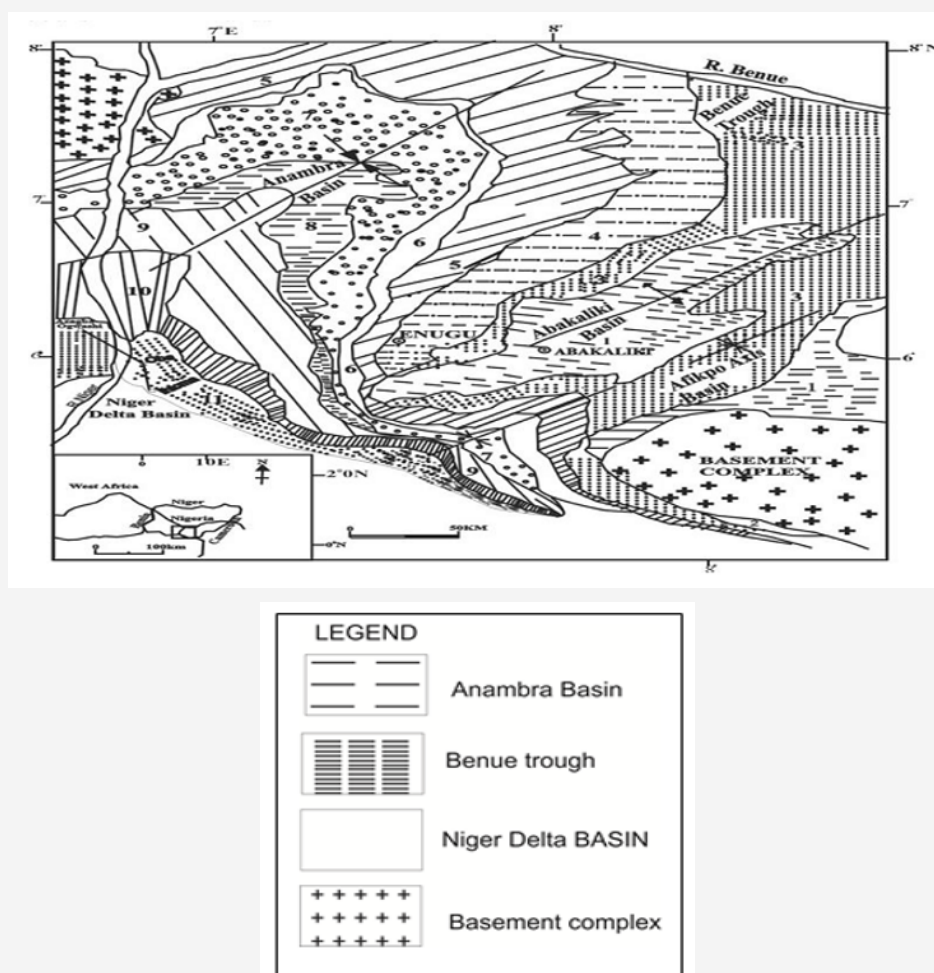
Figure 2: Geologic map of south-eastern Nigeria showing the study area [37].

The Geology of the area is a major factor in gully erosion causation and massive landslides that occur in several communities. The sandy members of the Ajalli Sandstone, Ameki Formation and Nanka Sands are very prevalent to denudation where they become exposed as sandy outcrops. Sometimes these sandy Formations have overlying and underlying shaley members that may bind the sandy units together. These Geologic Formations contain saturated groundwater members or aquifers whose pore water pressures enhance groundwater flows and movement of sedimentary materials. Sedimentary units of these Formations sometimes form escarpments or cuestas that may be folded and faulted with fractures of joints and faults all of with planes of weaknesses which facilitate the incidences of gully erosion and landslides. Blocks of sedimentary units of rocky sands and shales may break out and slide downslope into the gully valleys.

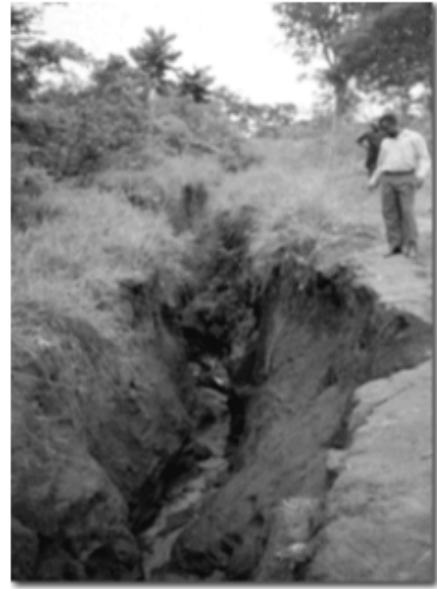
Figure 3: Gully erosion site in Amaokwe.

- **Displacement of Large Population of People and Refugees:** The entire Communities in Amaokwe (see some erosion sites in Figures 3&4), Abia State University, Uturu, Ogudasa and Oruruala were completely displaced due to the expansion of gully sites. The Amuzukwu community in Umuahia North L.G.A of Abia State suffered the same fate and is now hapless refugees.

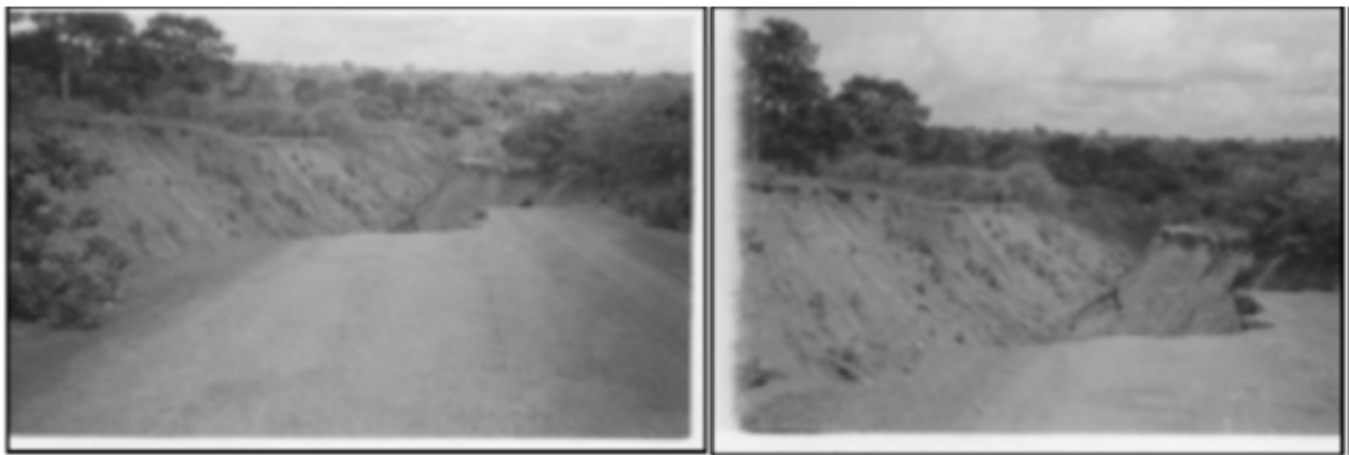
Figure 4: Eroded sites in Amaokwe Community, Abia State.

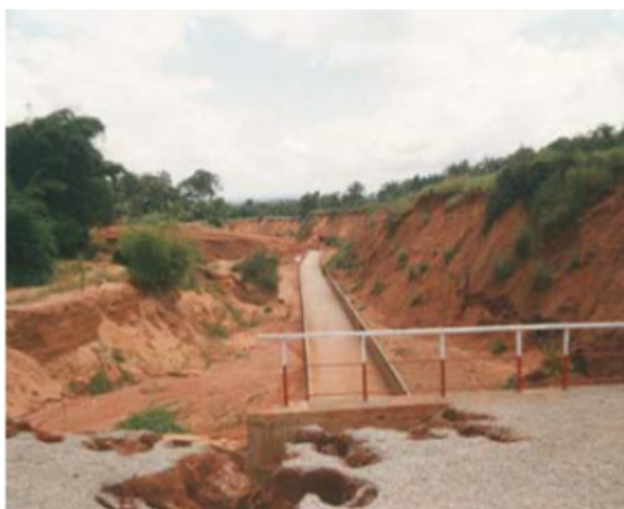
Figure 5: A Gully site in Umuchiana, Aguata, Anambra State, Abia State.

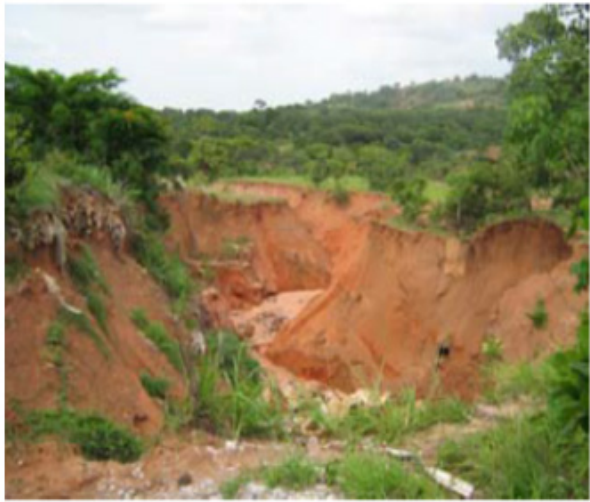
Figure 6: Gully Site at Nach-Agbalaenyi, Enugu State.

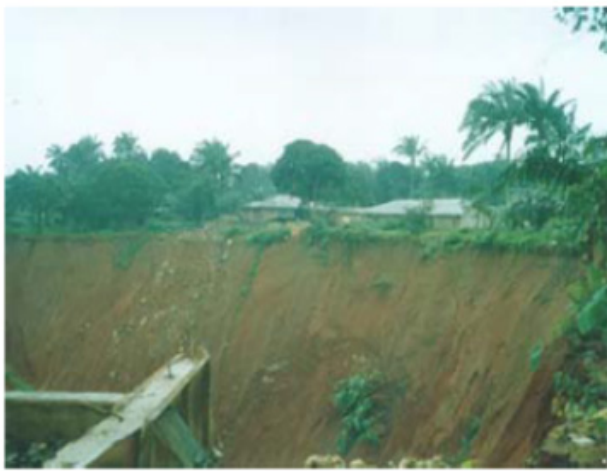
Figure 7: A Gully Site in Umuchu, Anambra State.

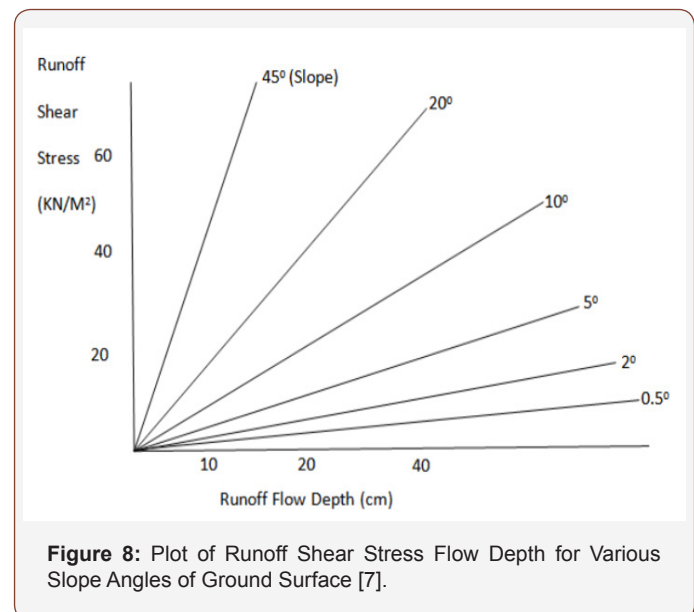
Figure 8: Plot of Runoff Shear Stress Flow Depth for Various Slope Angles of Ground Surface [7].

Findings from previous research [12] revealed that soil and gully erosion would be expected to occur when the shear stress of runoff exceeds the soil shear strength. Table 3 and Figure 8 show that the shear strength of topsoil's is higher than the shear stress of runoff for normal ground surface slope angles of less than 50 and

few depths that occur naturally (much less than 10cm). The red earth (RE) and, in particular, the bottom parent material (FS) have a shear strength values that are less than or marginally comparable to runoff shear stress, more so when flow is not concentrated. It is thus clear that once the topsoil is removed and/or runoff is concentrated (i.e. increase in flow depth), erosion is inevitable. One obvious way by which the top soil is removed and run off is concentrated is through recklessly-executed road construction and civil engineering works and to a very much less degree by traditional or even sophisticated farming practices, suggesting that civil works rather than farming practices are responsible for the erosion problems.
